NATIONAL TRANSPORTATION SAFETY BOARD

HAZARDOUS MATERIALS SPECIAL INVESTIGATION REPORT

COLLISION BETWEEN
A TRACTOR-SEMITRAILER
TRANSPORTING BOMBS AND
AN AUTOMOBILE,
RESULTING IN FIRE AND EXPLOSIONS
CHECOTAH, OKLAHOMA
AUGUST 4, 1985

NTSB/SIR-87/01

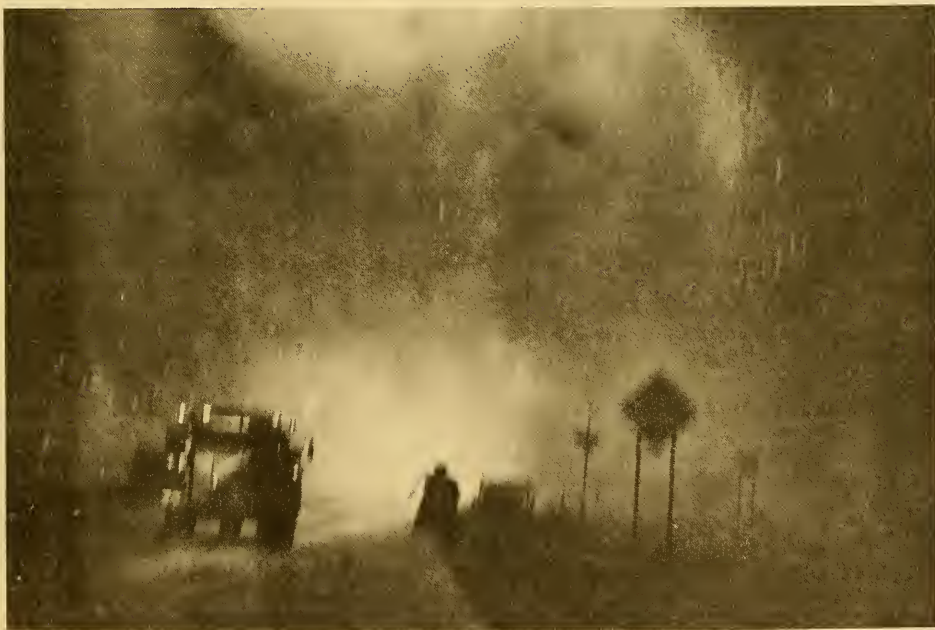
About 3:45 a.m., the fire trucks were preparing to withdraw from the I-40 accident site when an explosion occurred. The fire chief said that he saw the mushroom effect of a bomb explosion and flying shrapnel and debris. He said that the explosion occurred near the front of the semitrailer and that, based on his military training, he was certain (after the incident) that a bomb had exploded. He described the explosion as "seeing a 104 or 105 Howitzer 1/ round go off, a bunch of Roman candles on the outside of it, and no flames." (See figure 1.)

Figure 1.--Fire chief's truck in foreground of explosion.

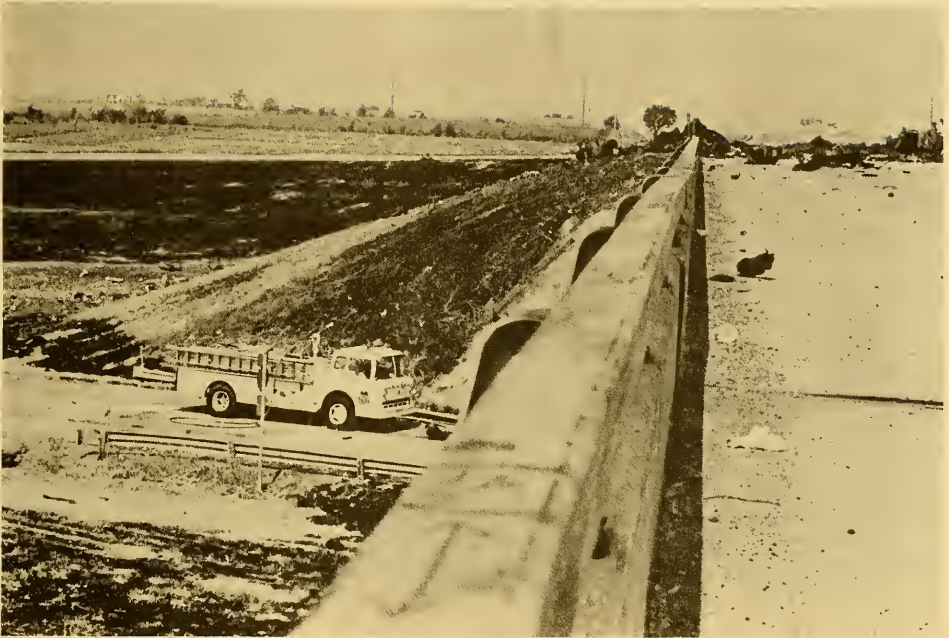
Figure 2.—Fire truck parked on "old" U.S. 69 about 150 feet east and 26 feet below the resting position of the semitrailer before the explosions.
(Photograph courtesy of the State of Oklahoma Department of Transportation.)

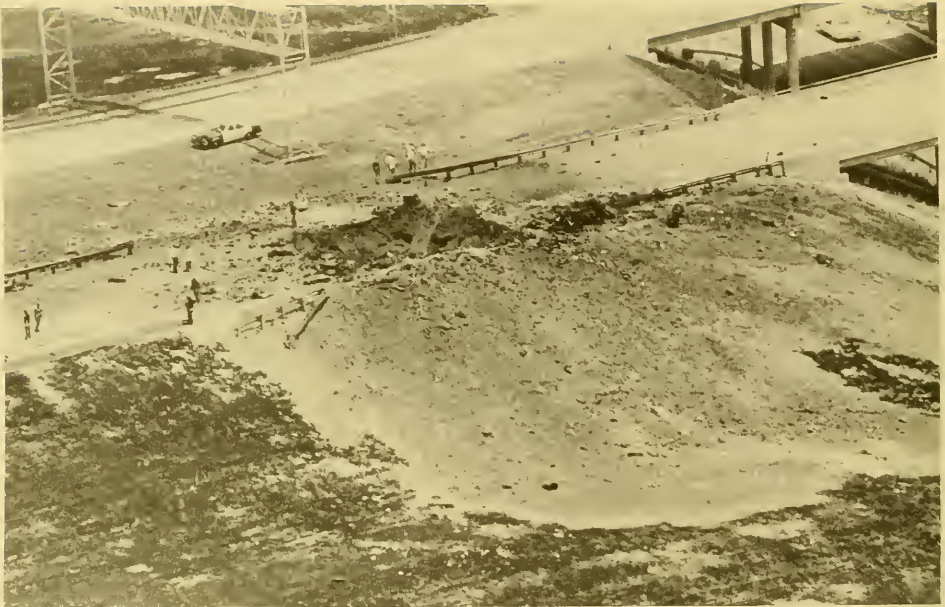
Figure 3.—Accident site.
(Photograph courtesy of the State of Oklahoma Department of Transportation.)

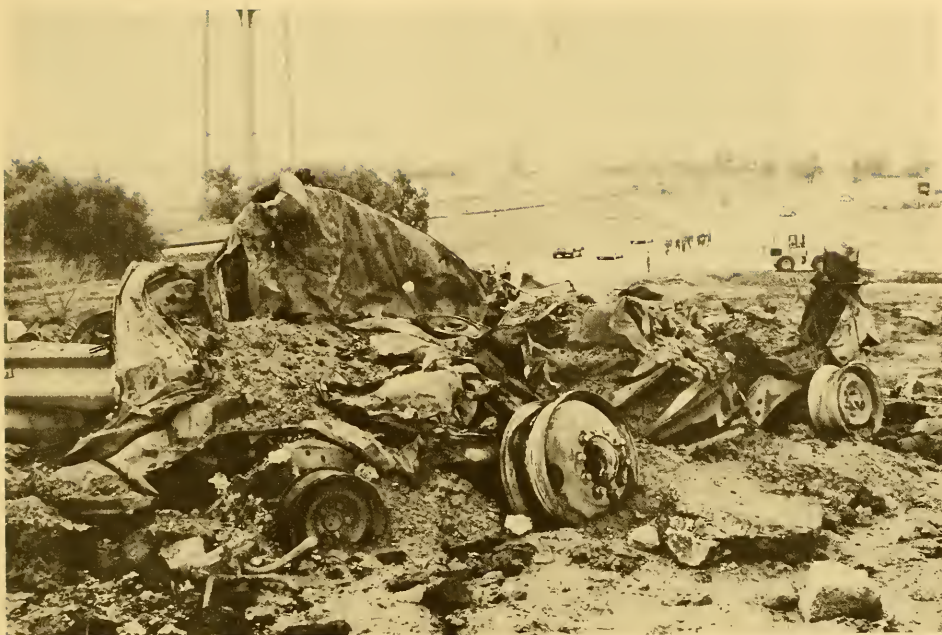
Vehicles.—The tractor-semitrailer and automobile were destroyed by fire and explosions after the accident. (See figure 5.) Examination of the wreckage disclosed that the automobile had sustained moderate impact damage to the left rear section. The rear

Figure 5.—Tractor-semitrailer and automobile wreckage after explosions and fire.

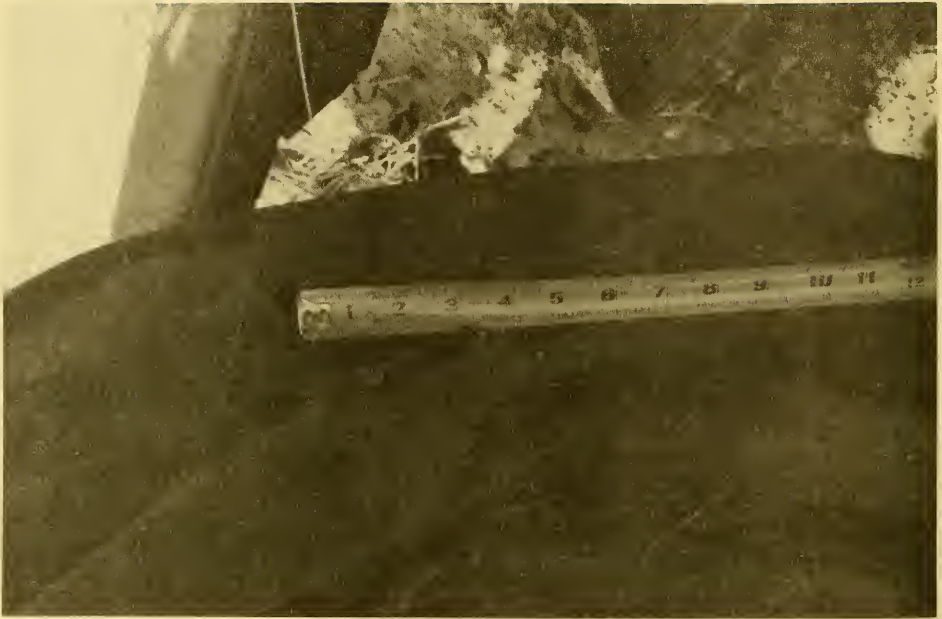
bumper was pushed forward about 18 inches and downward into the 26-gallon capacity fuel tank. ^{2/} This penetration was about 56 inches to the left of the right edge of the bumper. A 5-inch split was found in the fuel tank adjacent to the area of maximum penetration by the rear bumper. (See figure 6.) The left frame rail was bent 23 inches downward from its point of attachment near the left rear shock absorber. It was crimped 32 inches forward of its attachment to the bumper.

Figure 6.—Automobile fuel tank.

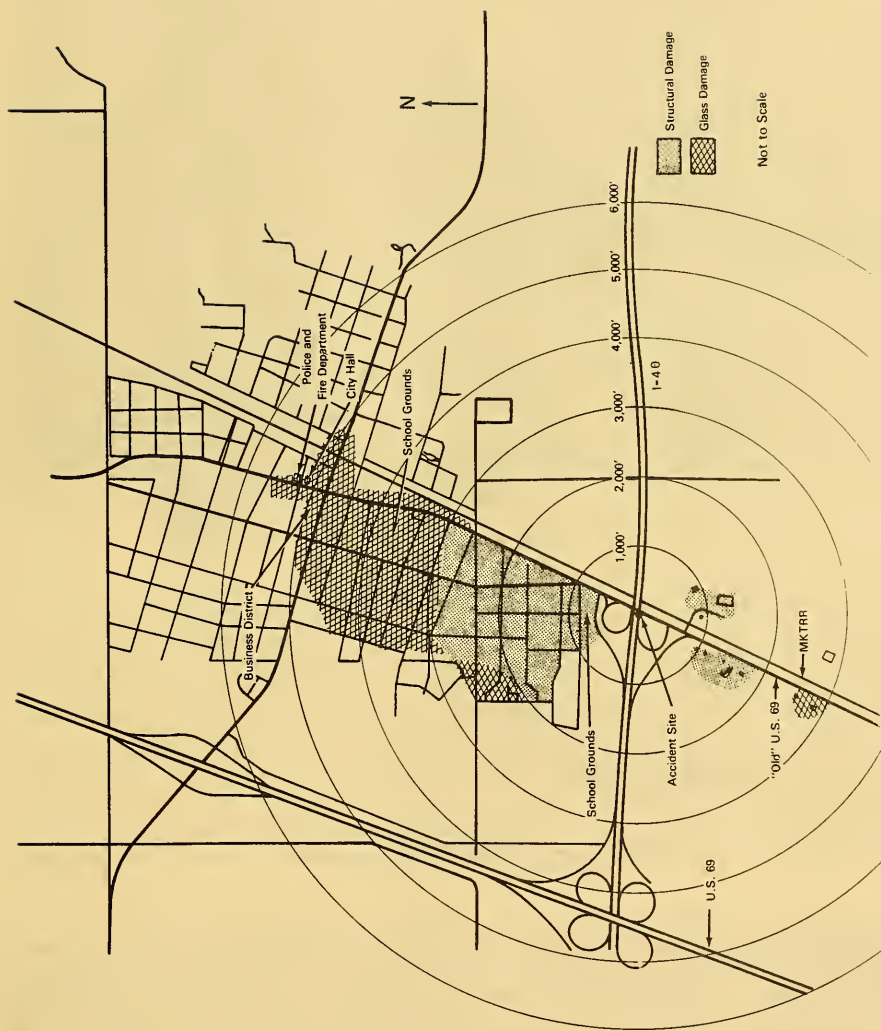
Other.—The concussion (overpressure) and flying debris from the explosions caused substantial damage to many structures in the Checotah area. Buildings nearest to and north of the accident site generally sustained the most severe damage. (See figure 7.) The explosions shattered windows, damaged roof trusses and door frames, collapsed ceilings and light fixtures, and weakened interior and exterior walls. Total property damage was estimated at \$5 million. ^{3/}

Figure 7.—Diagram of concentrated areas of structural and glass damage to buildings, Checotah, Oklahoma.

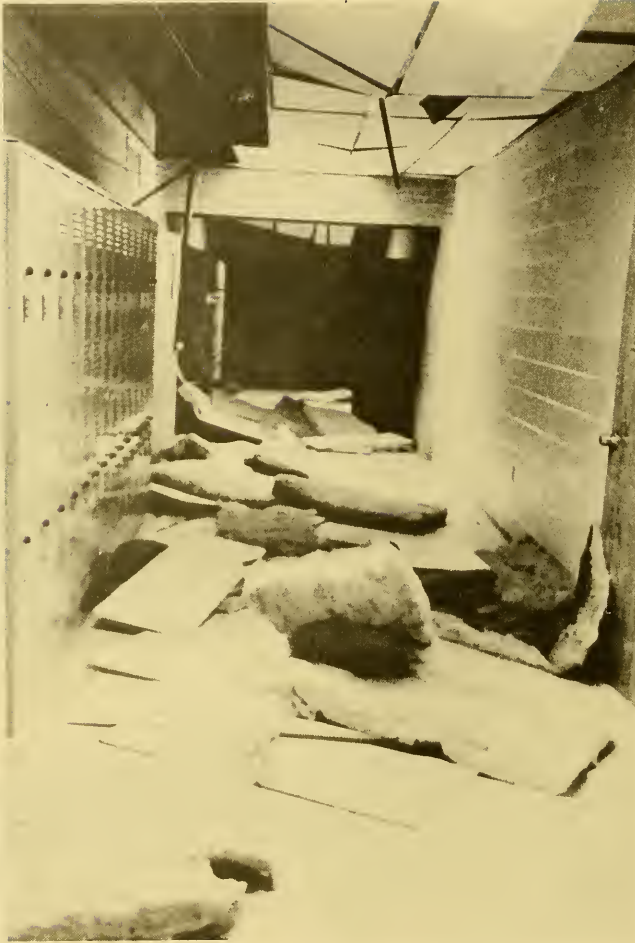
Several school buildings, a manufacturing plant, and two gasoline stations also incurred substantial damage. Damages to the Checotah Middle School, located about 734 feet north of the accident site were estimated at \$215,000. Damage to other school buildings was estimated to be \$85,000. (See figure 8.) Damage to commercial structures was estimated to be \$225,000. About 60 percent of the plate glass windows in downtown Checotah (about 1 mile from the accident site) were shattered. (See figure 9.)

Figure 8.—Damage at Checotah school
located near accident site.

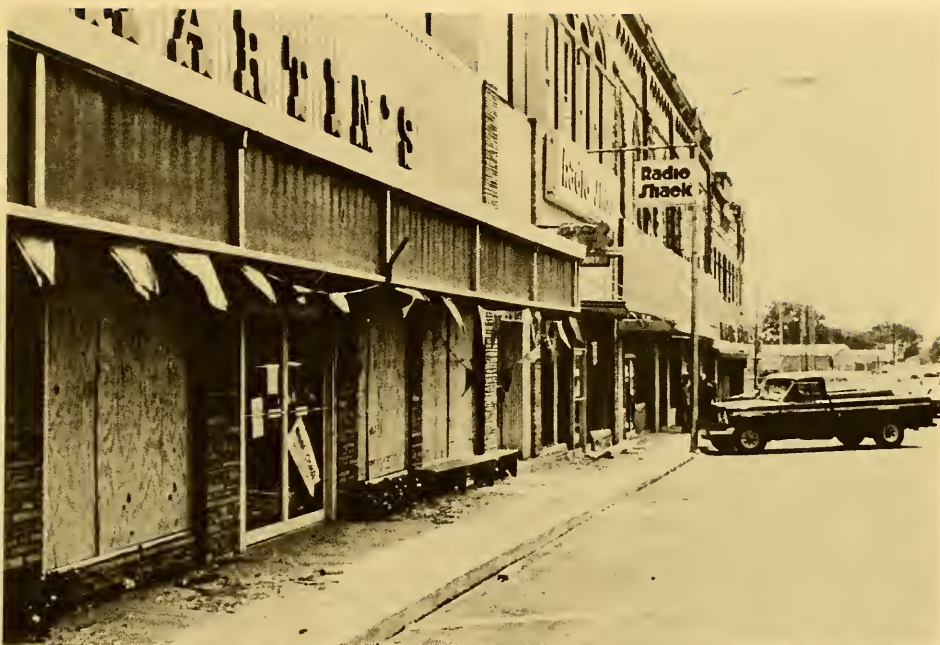
Figure 9.—Chcotah central business district located about 1 mile from the accident site.

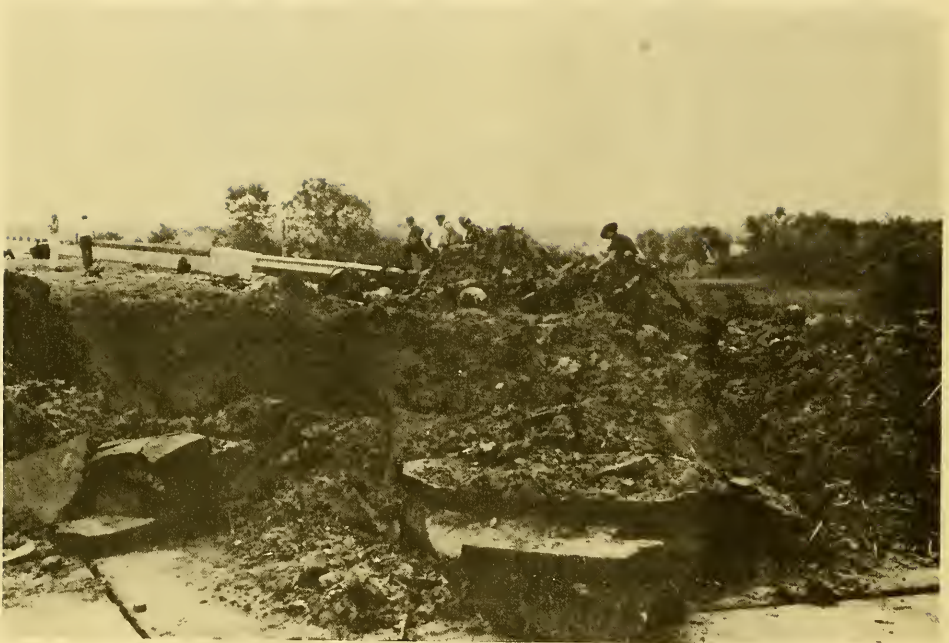
The explosions also destroyed a Checotah fire truck, two eastbound lanes of I-40, a merge lane from the "old" U.S. 69 entrance ramp, the right shoulder of the highway, several feet of guardrail, and numerous highway signs. (See figure 10.) Approximately 3,382 tons (1,700 cubic yards) of material were used to fill the crater left by the explosions. The Oklahoma Department of Transportation reported repair costs to be about \$85,000.

Figure 10.—Damaged I-40 eastbound lanes at accident site.

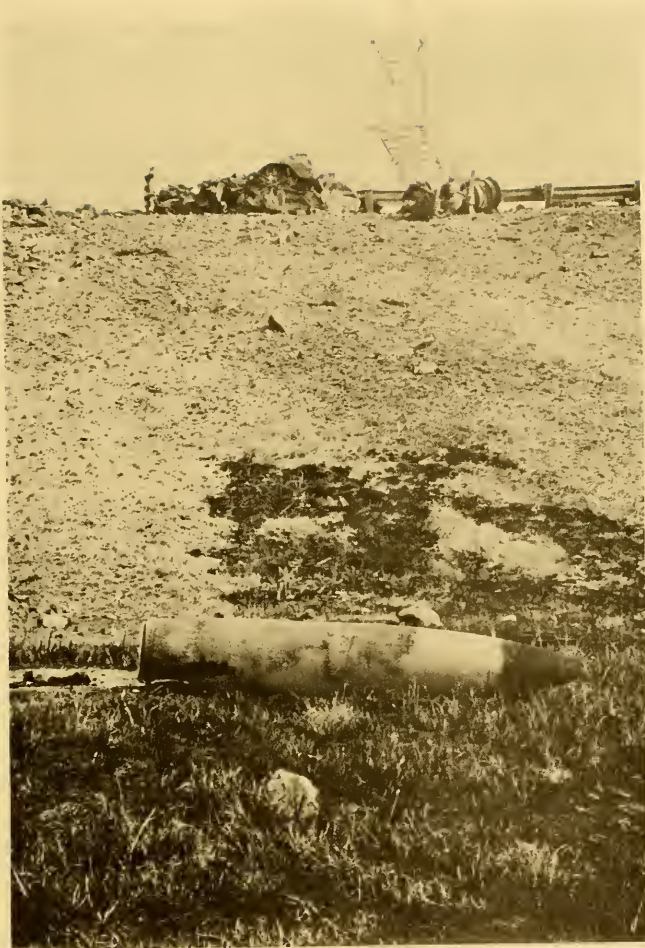
Figure 11.—MK 84 general purpose bomb at accident site.
(Photograph courtesy of the State of Oklahoma Department of Transportation.)
